Coating Repair Patch (CRP)

Description

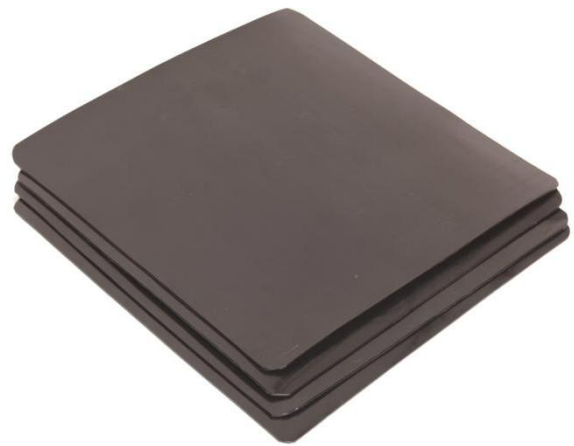
Our coating repair patch is specifically developed for repairing anti-corrosion coating damage on steel pipelines caused by impact. It consists of a radiation-crosslinked polyolefin substrate and a specialized sealing hot-melt adhesive. During application, the repair patch is heated to melt the specially formulated hot-melt adhesive coating, which then tightly bonds with the damaged area. This forms an integrated connection with the pipeline's original external anti-corrosion layer and adheres evenly to the pipe surface, establishing a continuous and sealed anti-corrosion system. The repair patch can withstand soil stress and hydrostatic pressure, effectively resisting cathodic disbondment, chemical corrosion, microbial erosion, and various other forms of corrosion, thus providing long-term protection for steel pipelines. The application scenario is suitable for wounds not exceeding 150 x 150mm (5.91 x 5.91in).
